Coal Mine Fatal Accident 2006-21

Operator:	Mettiki Coal LLC
Mine:	Mettiki Mine
Accident Date:	February 17, 2006
Classification:	Powered Haulage
Location:	Dist. 3, Garrett County, Maryland
Mine Type:	Underground Coal Mine
Employment:	114
Production:	23,000 Tons/Day

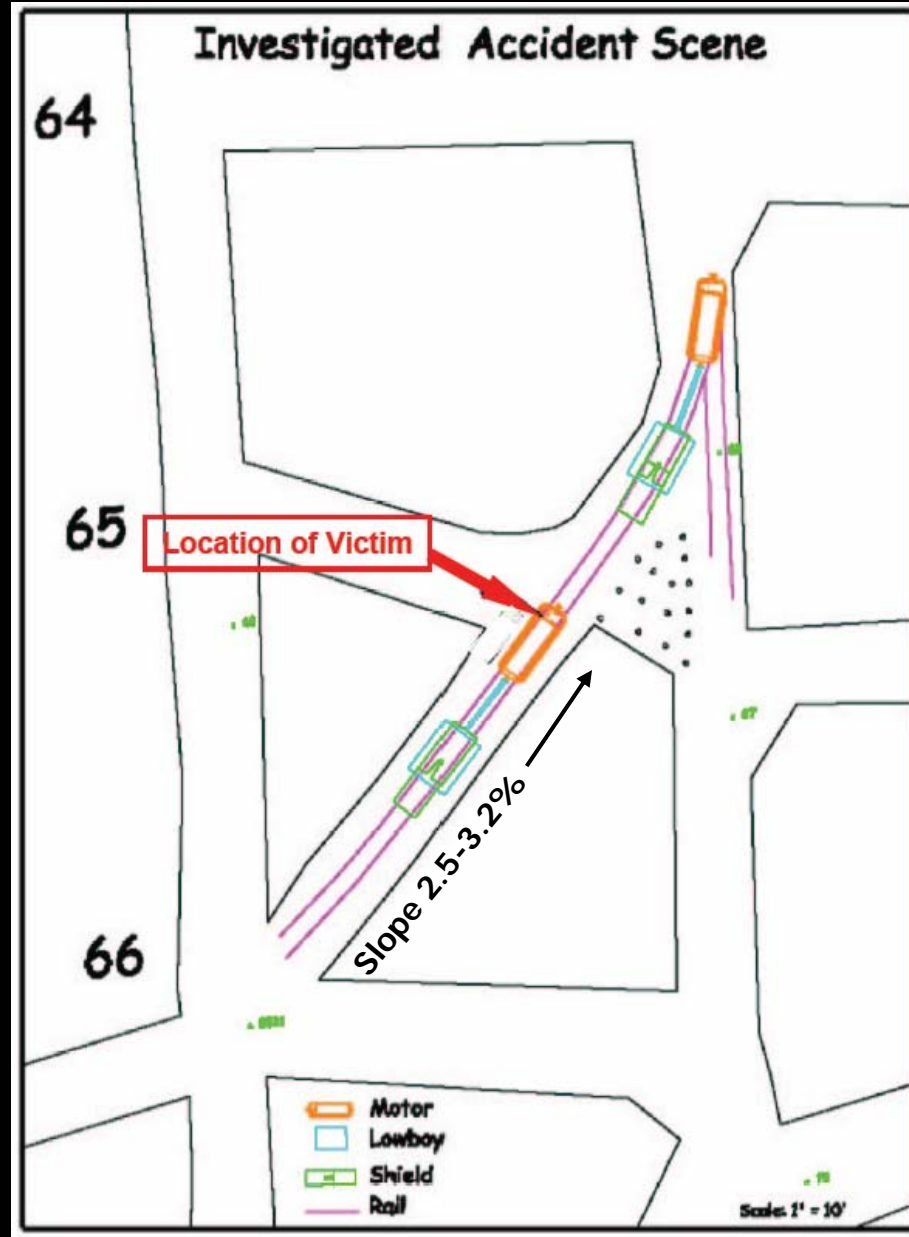
On Friday February 17, 2006, at approximately 9:30 pm, a 35-year old roof bolting machine operator, was fatally injured while operating a diesel-powered locomotive during a longwall move. The locomotive he was operating struck a parked lowboy rail car that was loaded with a longwall shield. The victim was crushed between the locomotive control panel and the tip of the longwall shield, which projected past the end of the lowboy.

Causal Factor: An effective procedure was not in place to protect miners from hazards during transportation of items such as longwall shields. The longwall shields were loaded on the low-boys in a manner that permitted the tip of the shield to overhang the car by approximately 8 feet and come into contact with the operator of another motor. There was no method of alerting the operator of the locomotive of the load sitting on the track in front of him.

Corrective Action: Two 314(b) Notices to Provide Safeguard were issued: (1) requiring longwall shields or other loads to be safely positioned; and (2) requiring the use of trip lights on all loads which do not use tailmotors. All underground employees were hazard/task trained in the plain meaning of the safeguard.

- Ensure that shields or other materials loaded for transport do not project into roadways or beyond the haulage equipment and are secured to prevent tipping or falling.
- Place an empty rail car adjacent to overhanging loads or an appropriate draw bar between the locomotive and the load.
- Require trip lights when a tail motor is not used.
- Provide protective cabs, canopies, or vertical intrusion shielding pipes on mobile equipment where clearance permits.
- Always look in the direction of movement, exercise caution when approaching parked equipment and set the automatic and manual braking systems when the locomotive is stopped.
